# Detection of Asphalt Pavement Potholes and Cracks Based on the Unmanned Aerial Vehicle Multispectral Imagery

**Abstract**—Asphalt roads are the basic component of a land transportation system, and the quality of asphalt roads will decrease during the use stage because of the aging and deterioration of the road surface. In the end, some road pavement distresses may appear on the road surface, such as the most common potholes and cracks. In order to improve the efficiency of pavement inspection, currently some new forms of remote sensing data without destructive effect on the pavement are widely used to detect the pavement distresses, such as digital images, light detection and ranging, and radar. Multispectral imagery presenting spatial and spectral features of objects has been widely used in remote sensing application. In our study, the multispectral pavement images acquired by unmanned aerial vehicle (UAV) were used to distinguish between the normal pavement and pavement damages (e.g., cracks and potholes) using machine learning algorithms, such as support vector machine, artificial neural network, and random forest. Comparison of the performance between different data types an

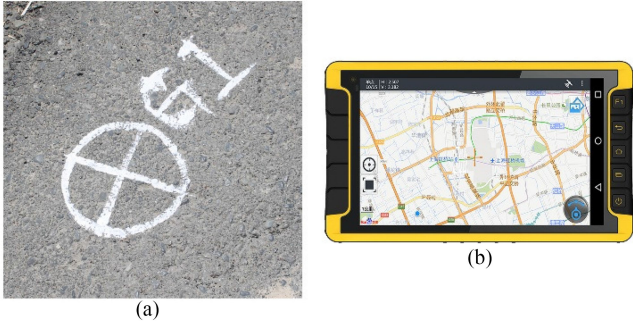
Fig. 2. (a) GCPs landmark. (b) Huace LT600T Client.

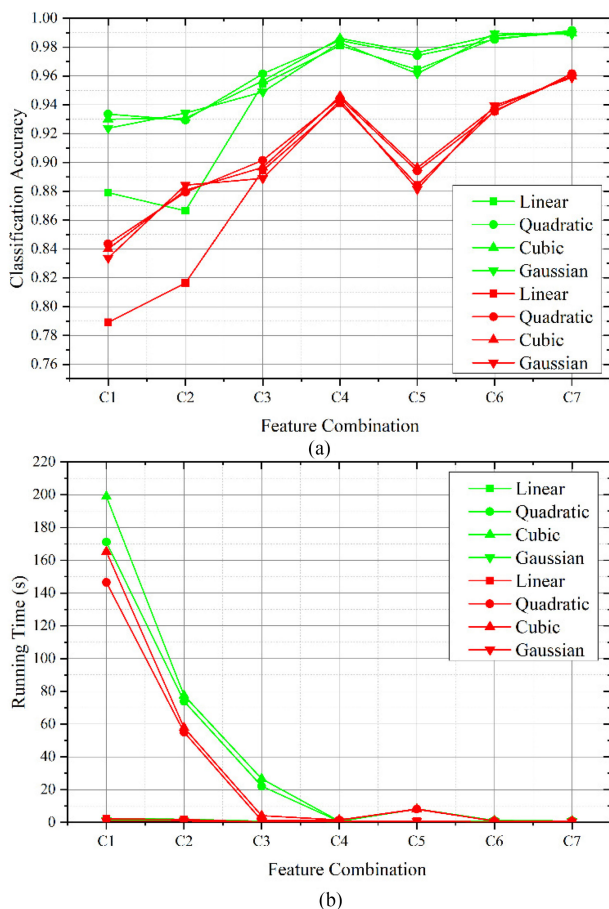
Fig. 7. (a) Classification accuracy and (b) running time of SVM algorithms over four types of kernel functions and seven feature combinations. The curves in red represent the result of the RGB images and the curves in green indicate the performance of the MSI.

Fig. 7 indicates the performance of an SVM configured with different types of kernel functions and seven feature

combinations. Fig. 7(a) shows that the SVM with linear kernel presented lower classification accuracy when it is trained and validated only using either spectral features or geometry features individually. Along with introducing texture features

or more types of features, the four kinds of SVM models (linear, quadratic, cubic, and Gaussian) almost performed similarly on feature combination C3, C4, C5, C6, and C7, and the highest accuracy was achieved by using three types of features together, i.e., C7. It can also be concluded that the accuracies derived from MSI are generally higher than from RGB images. Fig. 7(b) indicates the running time of different SVM models. It can be seen that the SVM with polynomial kernels (quadratic and cubic) cost most time on the feature sets of C1, C2, and C3. For C4, C5, C6, and C7, all types of SVM models performed similarly on the running time. It is interesting that the SVM models with linear and Gaussian kernel took almost the same time on each of six feature combinations. Considering the as higher accuracy as possible and relative less running time, Fig. 7 shows that the SVM model configured with linear kernel and the feature combination C7 could achieve the highest classification accuracy of 98.78% while cost the least running time of 0.63 s from the MSI.

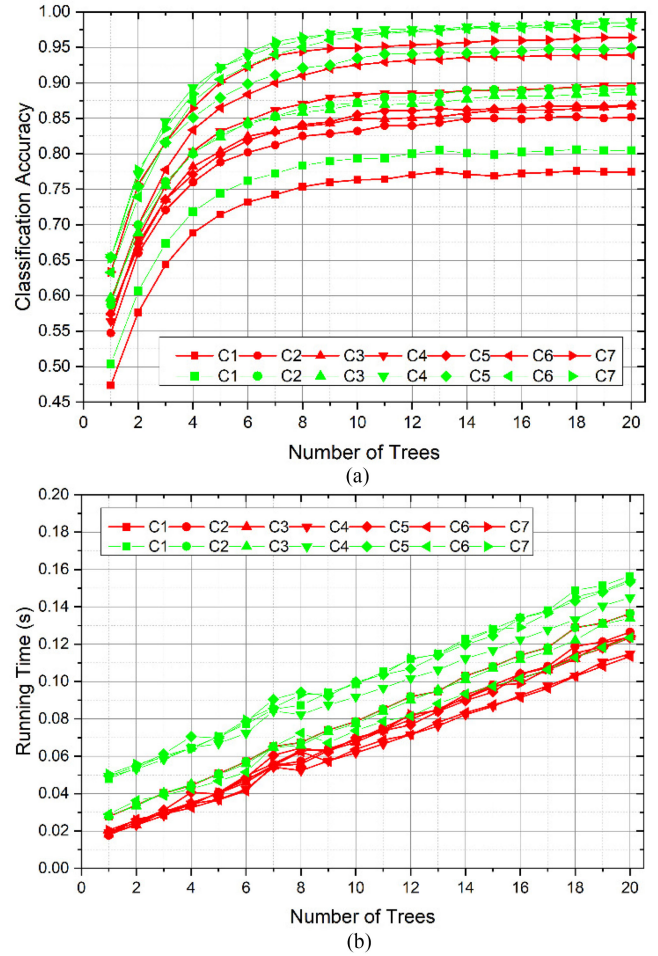
Fig. 9. (a) Classification accuracy and (b) running time of RF algorithms over a series of numbers of trees and seven feature combinations. The curves in red represent the result of the RGB images and the curves in green indicate the performance of the MSI.

Appropriate number of decision trees in the forest greatly contributes to the accuracy and efficiency of RF classification. As a result, we selected a series of numbers of trees to optimize the best forest size for pavement damages detection. The performance of RF with different number of trees in the forest and two types of images is shown in Fig. 9(a). Obviously, the accuracy of RF classification maintained increases along with the growth of quantity of trees till a flat trend. The feature combinations with one more type of features (i.e., C4, C5, C6, and C7) always achieved better classification. Spatial features, namely geometry and texture, played a crucial role in improving the classification. Compared with the RGB images, the RF classification of the multispectral pavement images has higher accuracy when using the same feature combinations. The running time of RF algorithms for different number of trees and the two types of images is illustrated in Fig. 9(b), which has demonstrated that the more trees were used in the forest and the longer time would be spent in the experiment. Because MSI contain more spectral features, longer running time was also consumed. Nevertheless,

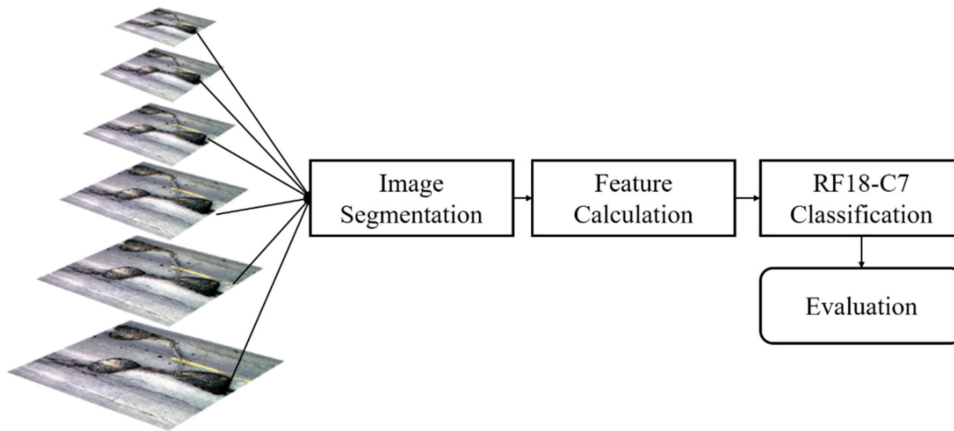
Fig. 11. Flowchart of evaluation of pavement image spatial resolutions.

The setting of UAV flight altitude can change the spatial resolution of pavement images acquired during the fly. Higher spatial resolution can provide rich features of road pavement objects, especially the spatial and textural features. However, higher spatial resolution also mean that the large storage memory should be used to store the volume data, and lower flight altitude has a degree of potential risk to the public traffic and people. Considering above-mentioned problems, appropriate spatial resolution should be determined prior to the flight task. In this experiment, the multispectral pavement images were resampled to a series of images with different spatial pixel sizes. Following the methods mentioned in Section II, these images were segmented into image objects first, and then the features of every object were calculated. The optimized model RF18-C7 was applied to classify the potholes, cracks, and nondistressed pavements (see Fig. 11). The test samples were collected in advance to evaluate the classification accuracy.

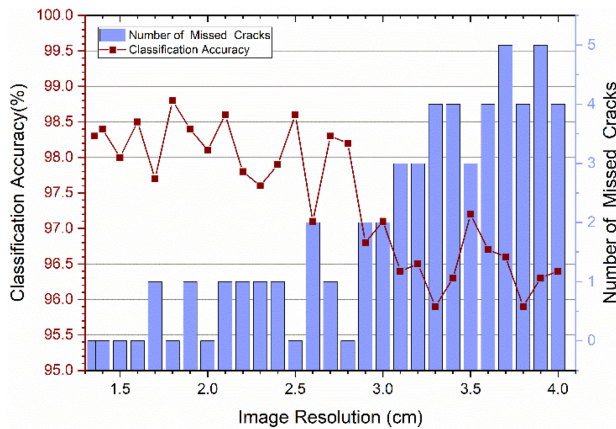
Fig. 12. Classification accuracy of MSI of pavement with different spatial resolutions and the number of missed cracks.

The classification accuracies using a series of multispectral pavement images with different resampled pixel sizes are shown in Fig. 12. It can be seen that the classification accuracy generally decreased while reducing the spatial resolution or pixel size. Due to the fact, the mean width of cracks is only 2.8 cm in our experiment, coarser image pixel size would lead to that some

cracks could not be segmented successfully when the resolution exceeded the minimum scale of the cracks, and consequently they would be missed finally in the classification. It is also can be seen in Fig. 12 that the number of missed cracks would increase when the pixel size was over about 3 cm. Therefore, the appropriate spatial resolution should not exceed the minimum scale of pavement objects, which requires that sufficient field works should be conducted before the flight task.

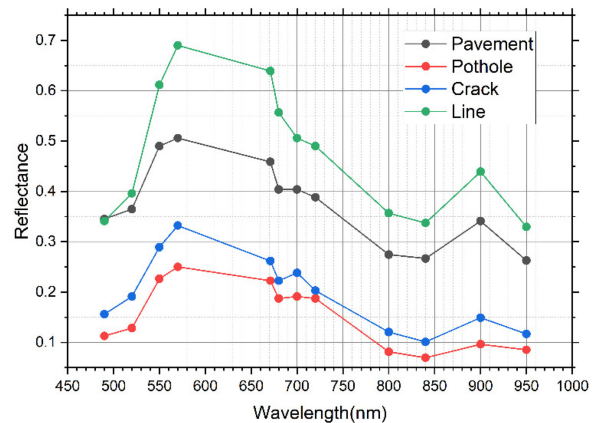
Fig. 14. Mean spectra of object of pavement, potholes, cracks, and traffic lines.

a great contribution to the detection of potholes and cracks. Combining with the detailed spectra of the pavement objects (see Fig. 14), it indicated that the reflectance of potholes and cracks was lower than nondistressed pavement and traffic line in the band wavelengths. The band reflectance centered at 570 nm and 900 nm has great difference between pothole, cracks, pavement, and traffic line, which is helpful to distinguish between them from each other.
